Technical Memorandum

Cedar Bayou/Vinson Slough Restoration Project

Aransas County, Texas

Weekly Summary 5/5 through 5/11

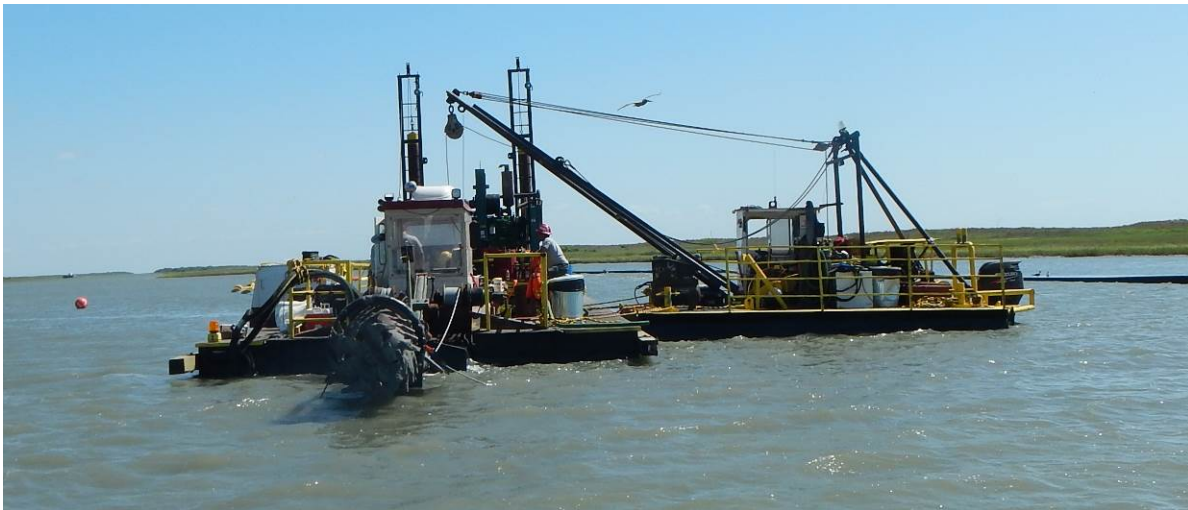
The hydraulic dredge has been mobilized along with over 13,000 linear feet of pipeline to transport sand from the dredge templates to the placement areas on the beach. Figure 1 shows the hydraulic dredge being prepped to start work.

Figure 1. The hydraulic dredge mobilized to the start of the Cedar Bayou dredging.

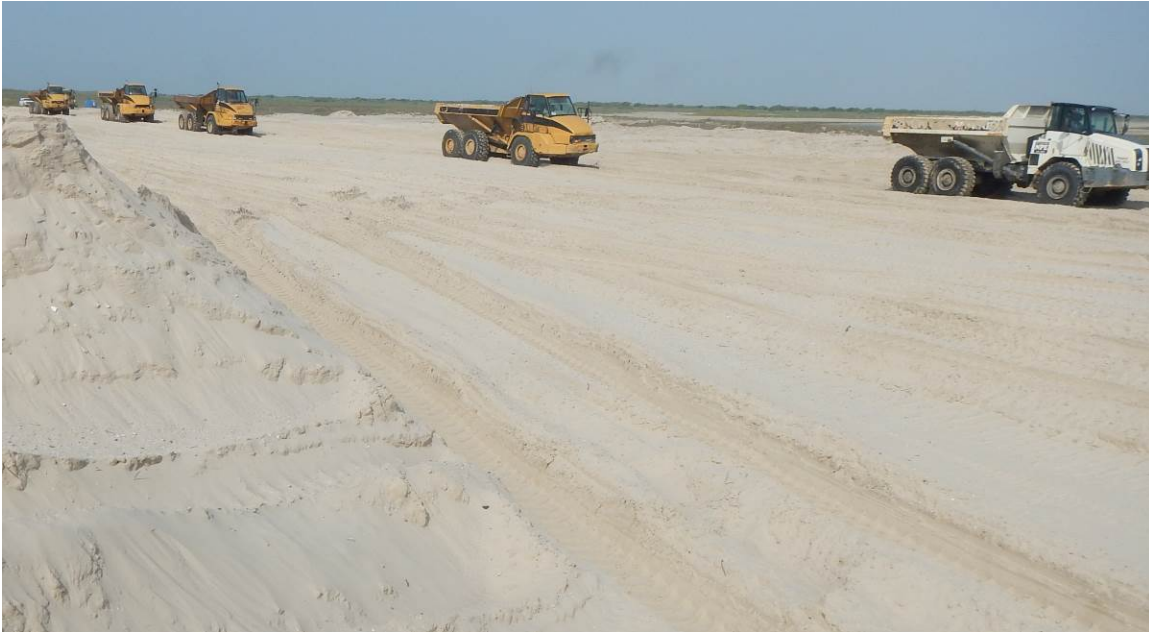
Figure 2 shows the trucks travelling to the spoil pile areas to be loaded.

Figure 2. Empty off-road trucks making their way to the spoil pile.

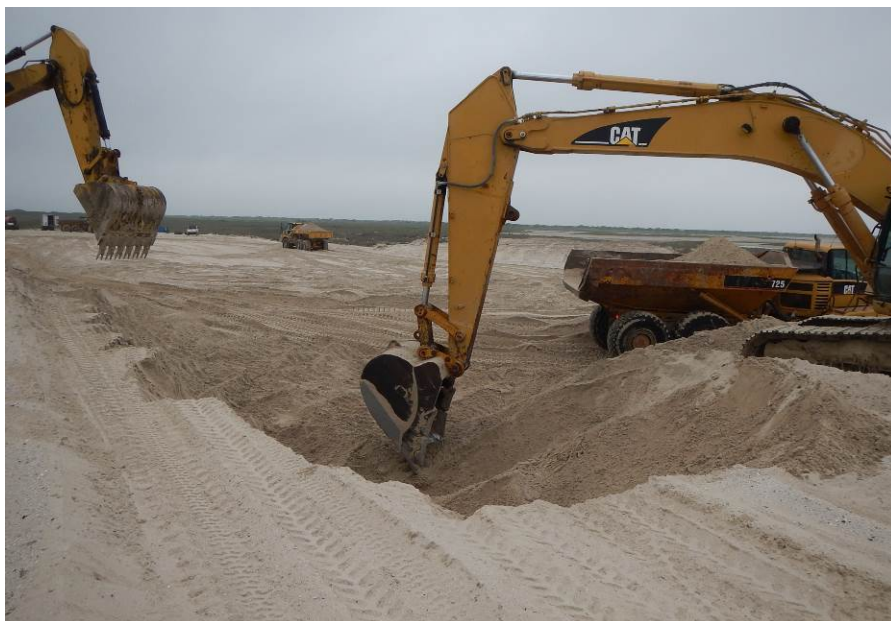
RLB is using 2 excavators to fill the off-road dump trucks with approximately 22 cubic yards of sand each to transport along the haul route to the placement areas as seen in Figure 3.

Figure 3. Excavators removing sand from the spoil pile.

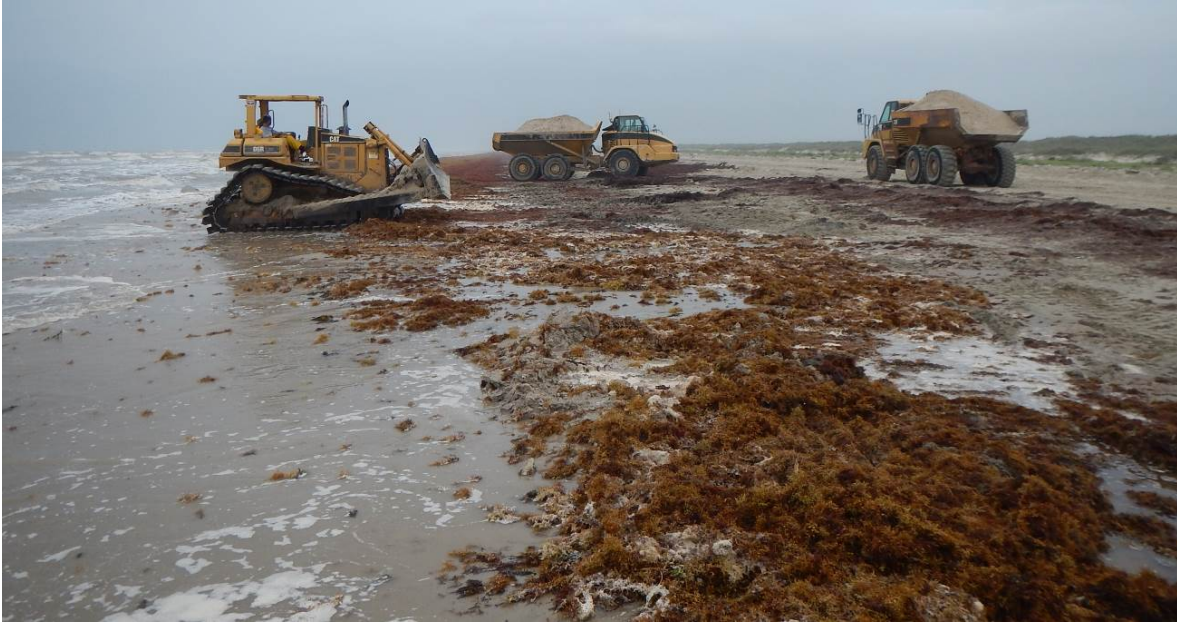
All material excavated from the spoil pile is transported along the haul route and dumped into Placement Area 1 and then graded by a bulldozer (Figure 4). To date, the material has been placed in approximately 1,000 feet of the 4,000 foot long placement area.

Figure 4. Bulldozer preparing to grade dumped sand in to Placement Area 1.

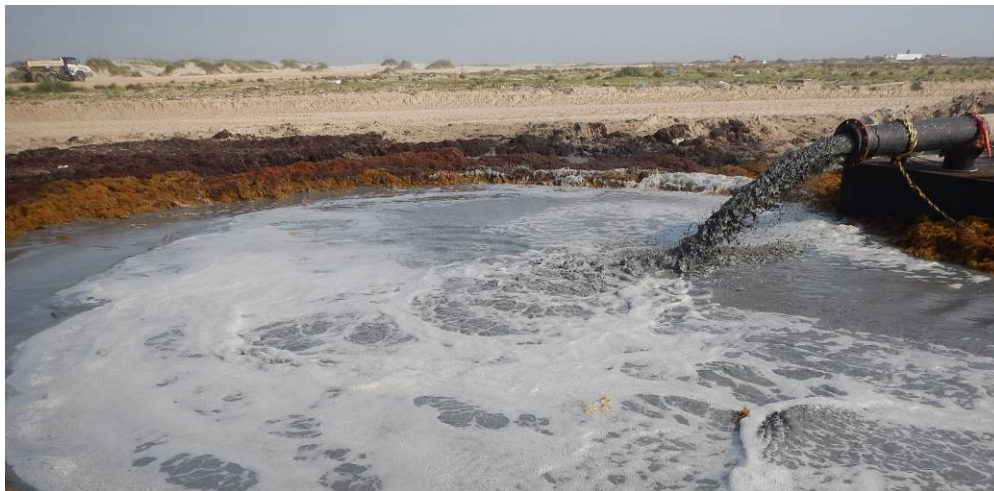
Sand transported by the hydraulic dredge has also been pumped to the northeast portion Placement Area 1. Figure 5 shows the sand pumped onto the beach through the pipeline, with very little accumulation seen. Although pressure is still low due to the long length of pipe, a diffuser is currently being built, and once installed on the end of the pipe will reduce potential for scouring at the point of discharge. All material placed in Placement Area 1 has been waterward of the MHHW line.

Figure 5. Hydraulic dredge pipeline discharging into Placement Area 1.
