Technical Memorandum
Cedar Bayou/Vinson Slough Restoration Project
Aransas County, Texas

Progress Update #3: 5/19 through 5/25

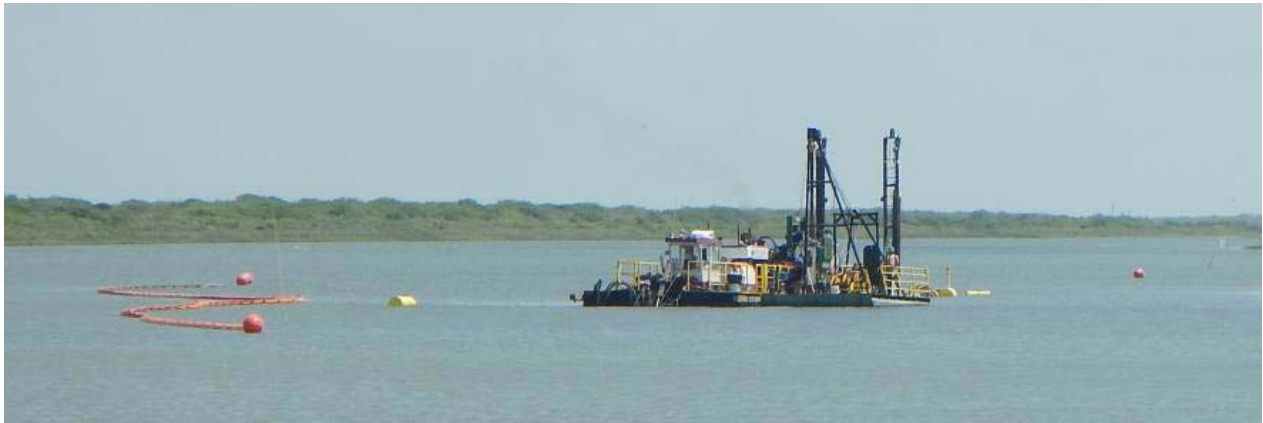
Dredging has continued in Cedar Bayou with approximately 1,400 feet of advance made during the past week. The contractor continues to maintain the silt curtains around the active dredging area to protect nearby aquatic resources. Figure 1 shows the hydraulic dredge working with support equipment nearby.

Figure 1. The hydraulic dredge in Cedar Bayou.

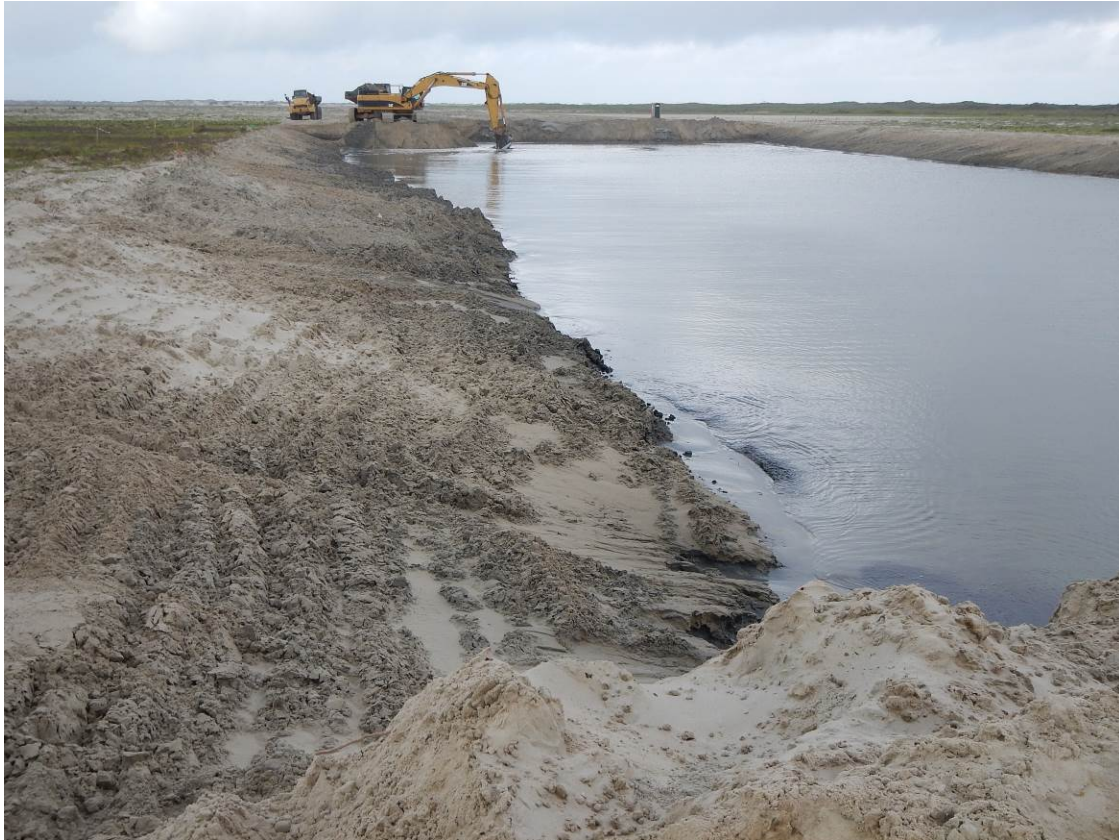
RLB continued excavation in Vinson Slough near the intersection with Cedar Bayou. On 5/20, a tern nest was discovered in the dredge template and no work distances were established to prevent the mother or eggs from being disturbed. The eggs hatched on 5/21 and the tern chicks have been monitored to date. The nest caused the contractor to shift excavation operations to the bay section of Vinson Slough which is affected by water level fluctuations. Progress is shown in Figure 2 with approximately 500 feet of advance total made in Vinson Slough.

Figure 2. Excavation of Vinson Slough (full channel dimensions shown)

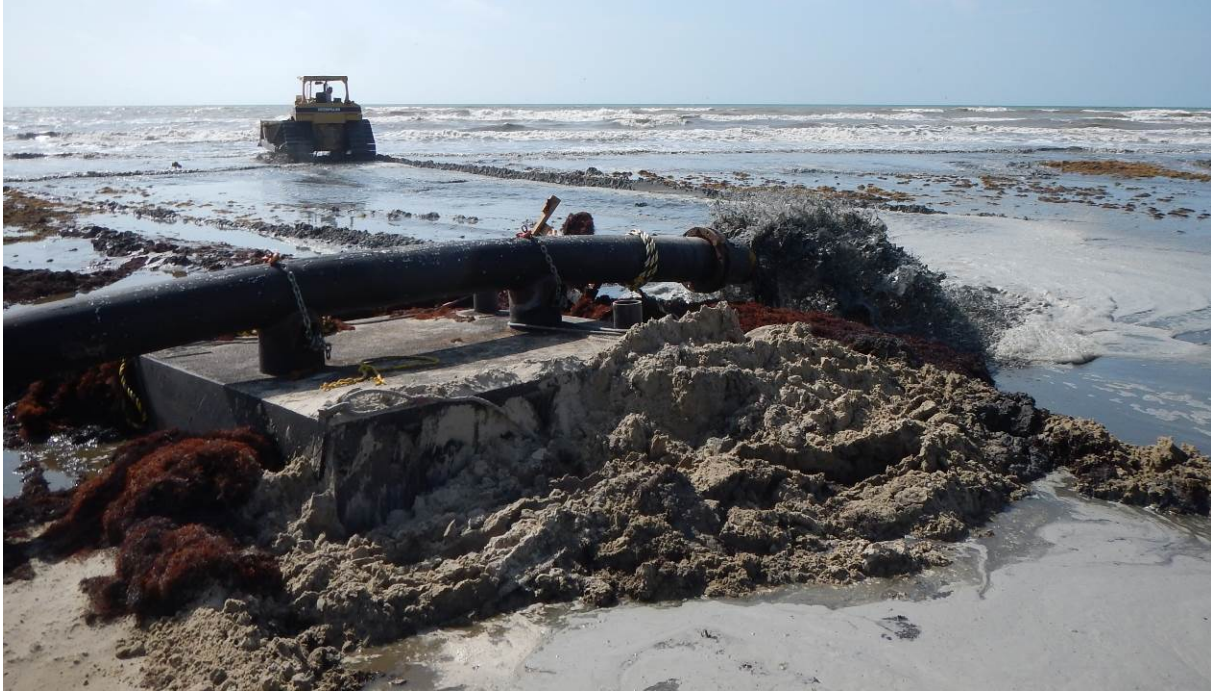
All material excavated from Vinson Slough is transported by off-road trucks along the haul route and dumped into Placement Area 1. Material dredged from Cedar Bayou is transported via pipeline to Placement Area 1. The contractor's dozer can be seen in Figure 3 blading out material into the surf zone that has built up near the pipeline discharge point. A diffuser is used on the end of the pipe to prevent scour of the beach as required by the project permit. All material transported to Placement Area 1 has been waterward of the MHHW line.

Figure 3. RLB's Dozer blading out material pumped from Cedar Bayou.

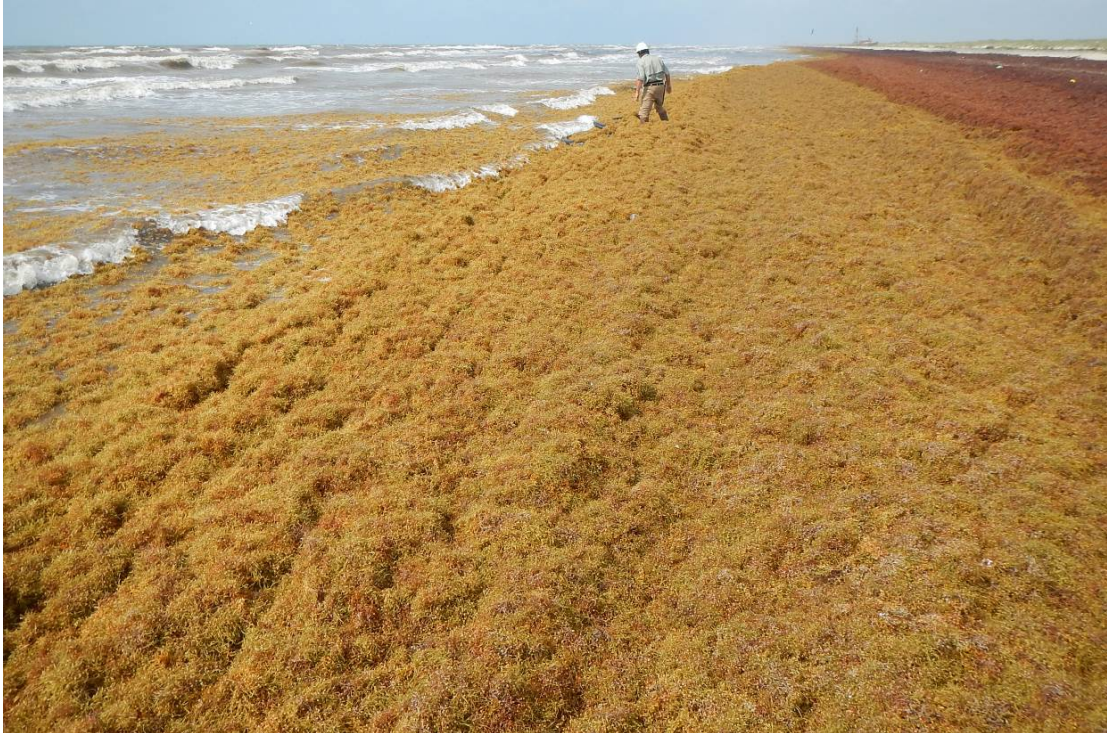
RLB's bird and turtle monitor patrolled the active work areas and work limits for any signs of turtle activity prior to the start of work every day, particularly in thick banks of washed up sargassum on the beach (Figure 4). No sightings of turtle nesting or piping plovers were recorded during this week. A tern's nest was discovered within the work template and all no-work buffers were immediately established as to not disturb the hatched chicks or the mother. RLB will continue to work in other areas of Vinson Slough until the tern chicks and mother have left the work area. The appropriate authorities were notified of the nesting tern as required by contract.

Figure 4. RLB's turtle monitor checking washed up sargassum for stranded turtles.
