Technical Memorandum Cedar Bayou/Vinson Slough Restoration Project Aransas County, Texas

Progress Update #4: 5/26 through 6/1

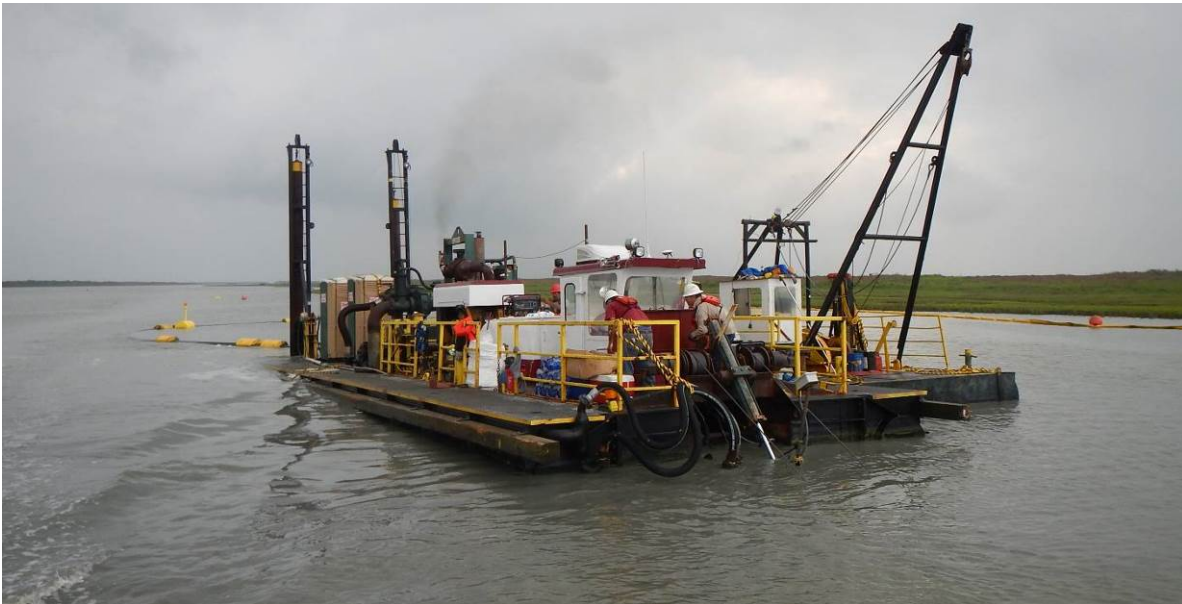
Dredging has continued in Cedar Bayou with approximately 1,800 feet of total advance since the start of the project. The contractor continues to maintain the silt curtains around the active dredging area to protect nearby aquatic resources as the dredge advances. Figure 1 shows the hydraulic dredge swinging across the specified dredge template.

Figure 1. The hydraulic dredge in Cedar Bayou.

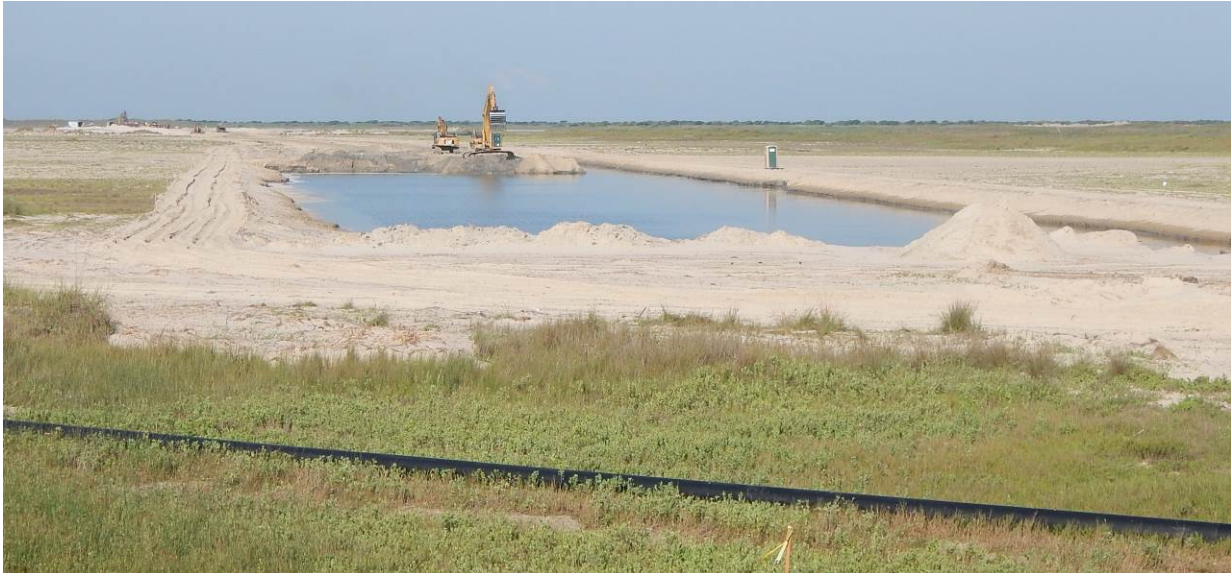
RLB continued excavation in Vinson Slough near the intersection with Cedar Bayou making a total advance of 600 feet along the design template. On 5/26, it was discovered that the tern nest and mother that had made a nest within the Vinson Slough template were no longer in the area.

and no signs in the original sighting location were observed. Progress in Vinson Slough is shown in Figure 2.

Figure 2. Excavation of Vinson Slough looking east from Cedar Bayou.

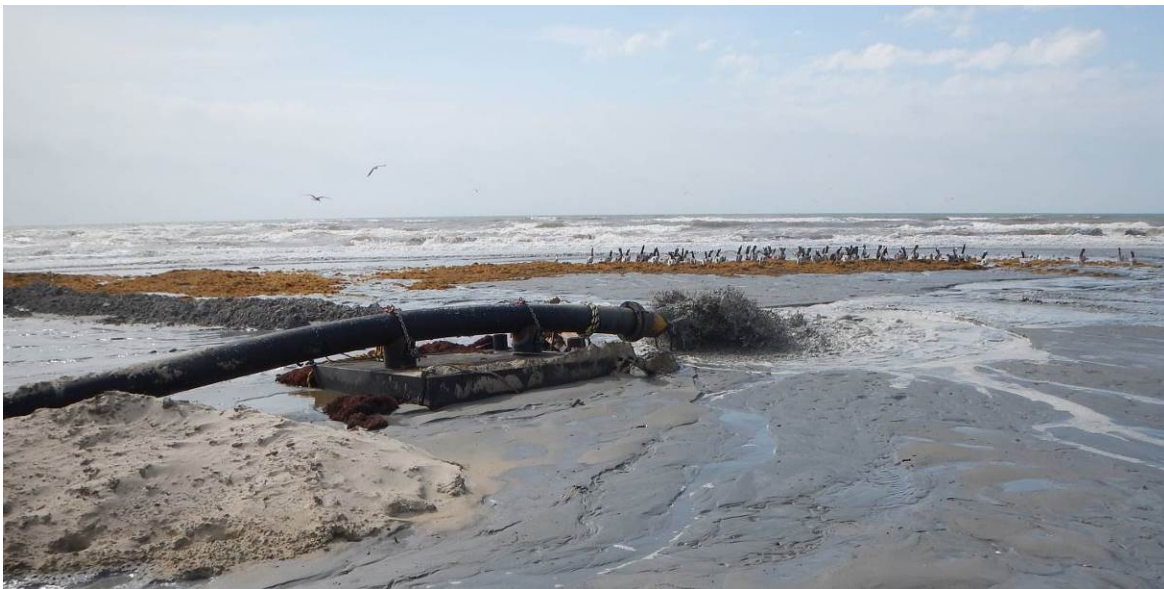
All material excavated from Vinson Slough is transported by off-road trucks along the haul route and dumped into Placement Area 1. Material dredged from Cedar Bayou is transported via pipeline to Placement Area 1. Figure 3 shows sand being pumped through the 13,000 feet of pipe to Placement Area 1. A diffuser is used on the end of the pipe to prevent scour of the beach as required by the project permit. All material transported to Placement Area 1 has been waterward of the MHHW line.

Figure 3. Sand being pumped from Cedar Bayou into Placement Area 1.
