**Technical Memorandum**  
**Cedar Bayou/Vinson Slough Restoration Project**  
**Aransas County, Texas**

**Progress Update #5: 6/2 through 6/8**

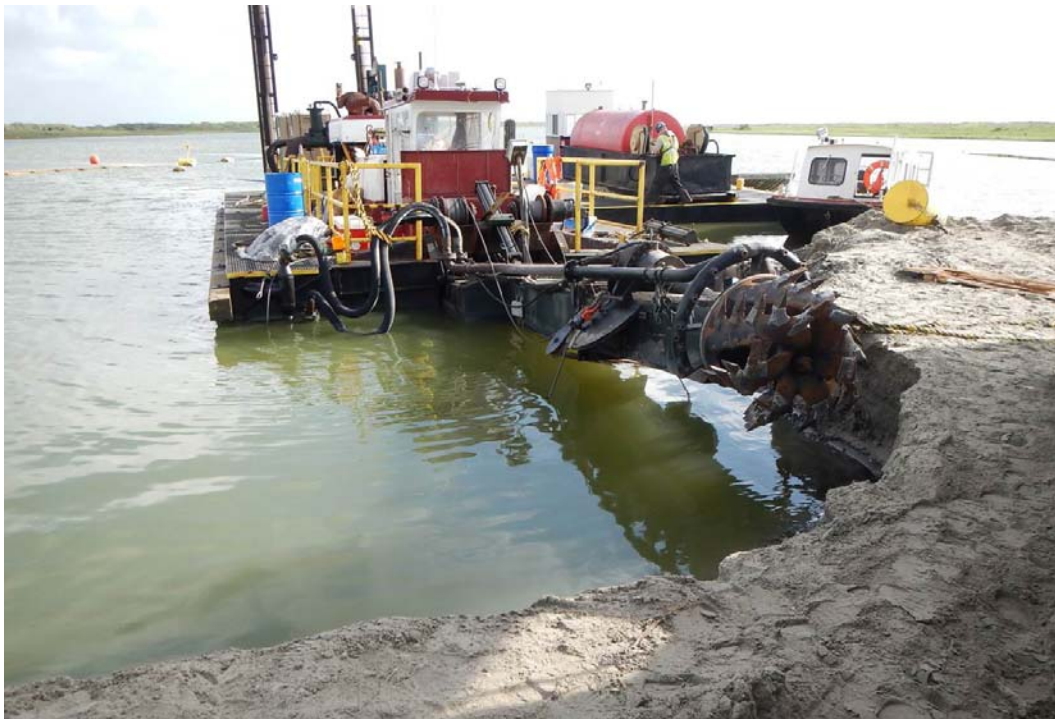
Dredging has continued in Cedar Bayou with approximately 2,300 feet of total advance since the start of the project. The contractor continues to maintain the silt curtains around the active dredging area to protect nearby aquatic resources as the dredge advances. Figure 1 shows the hydraulic dredge down for minor repairs during the past week.

**Figure 1. The hydraulic dredge in Cedar Bayou being repaired**

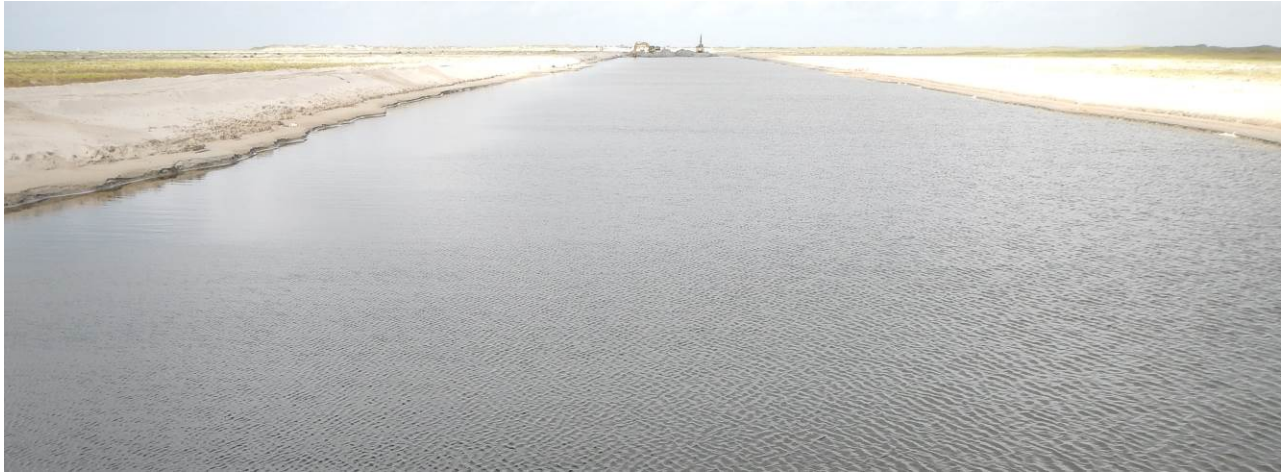
RLB continued excavation in Vinson Slough near the intersection with Cedar Bayou making a total advance of 1,600 feet along the design template using 2 excavators and 7 off-road dump trucks. Progress in Vinson Slough is shown in Figure 2.

**Figure 2. Excavation of Vinson Slough looking east from Cedar Bayou.**

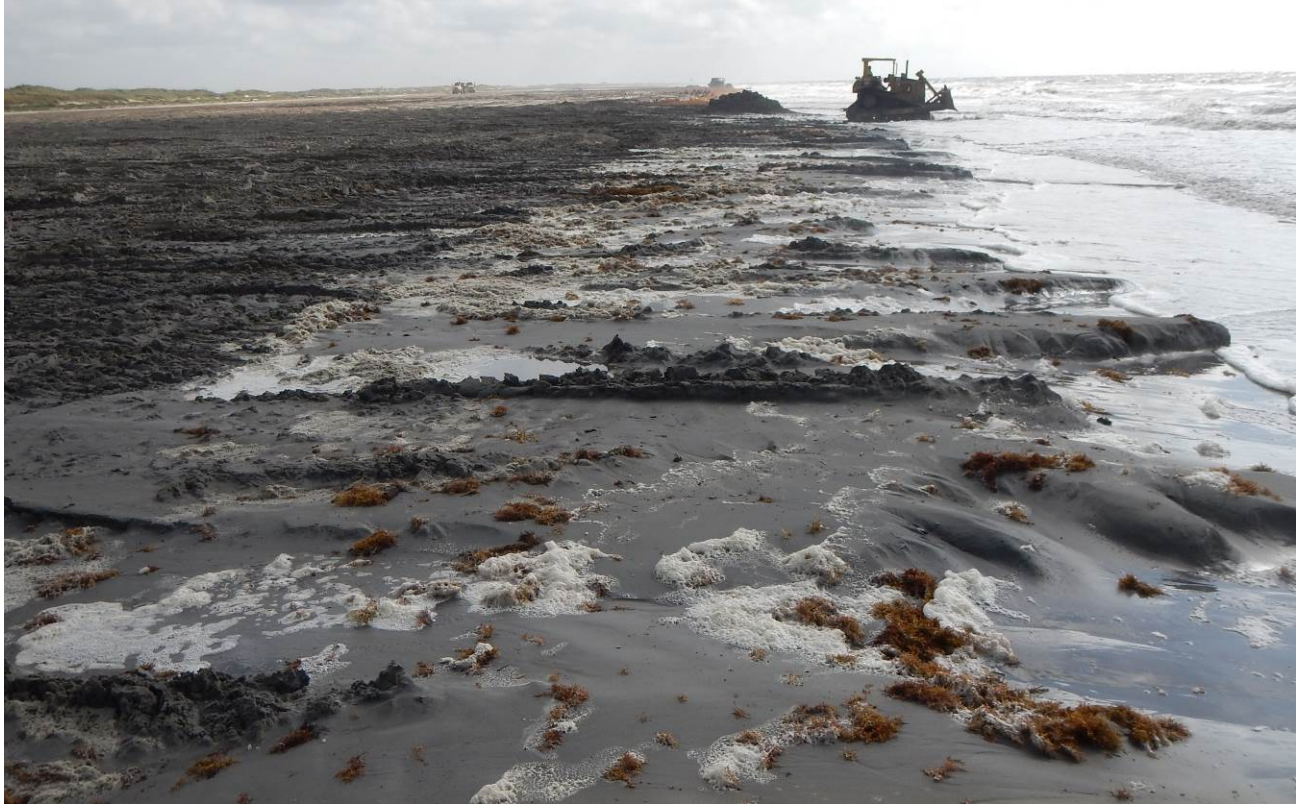
All material excavated from Vinson Slough is transported by off-road trucks along the haul route and dumped into Placement Area 1. Material dredged from Cedar Bayou is transported via pipeline to Placement Area 1. Figure 3 shows sand being graded out with one of RLB's bulldozers into Placement Area 1. A diffuser is used on the end of the pipe to prevent scour of the beach as required by the project permit. All material transported to Placement Area 1 has been waterward of the MHHW line.

**Figure 3. Material hauled from Vinson Slough being graded into Placement Area 1.**
