## **Technical Memorandum Cedar Bayou/Vinson Slough Restoration Project Aransas County, Texas**

### **Progress Update #18: 9/01 through 9/07**

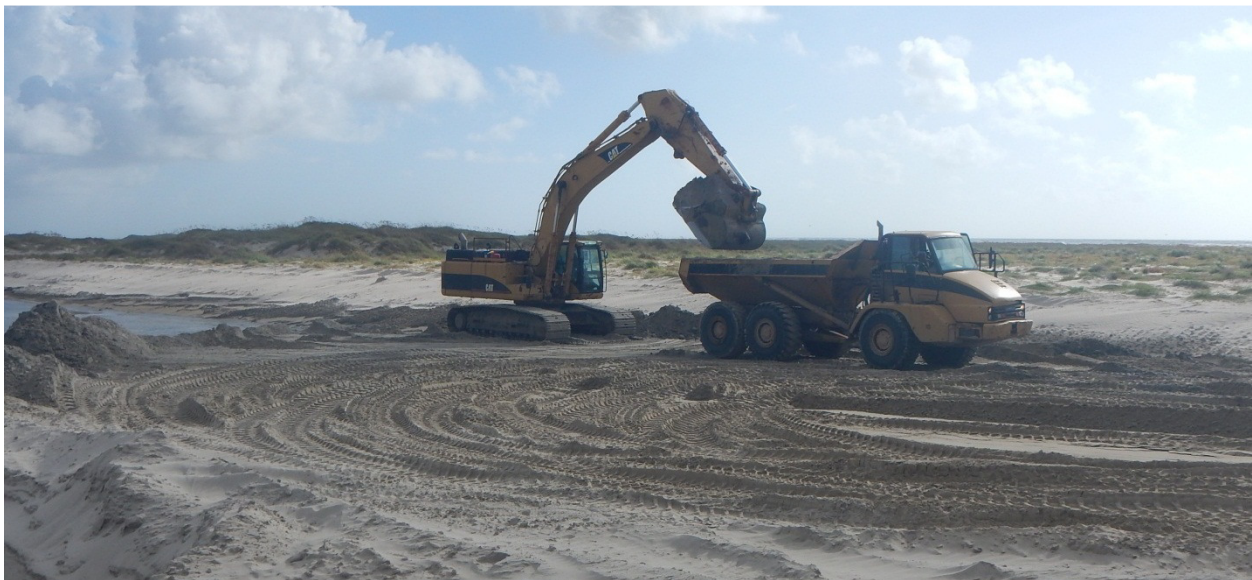
Excavation of Cedar Bayou has continued this week using 1 excavator and 6 off-road trucks. The total advance in Cedar Bayou is approximately 5,950 feet since the start of the project. An excavator working in Cedar Bayou can be seen in Figure 1.

**Figure 1. Excavator executing the full cut in Cedar Bayou.**

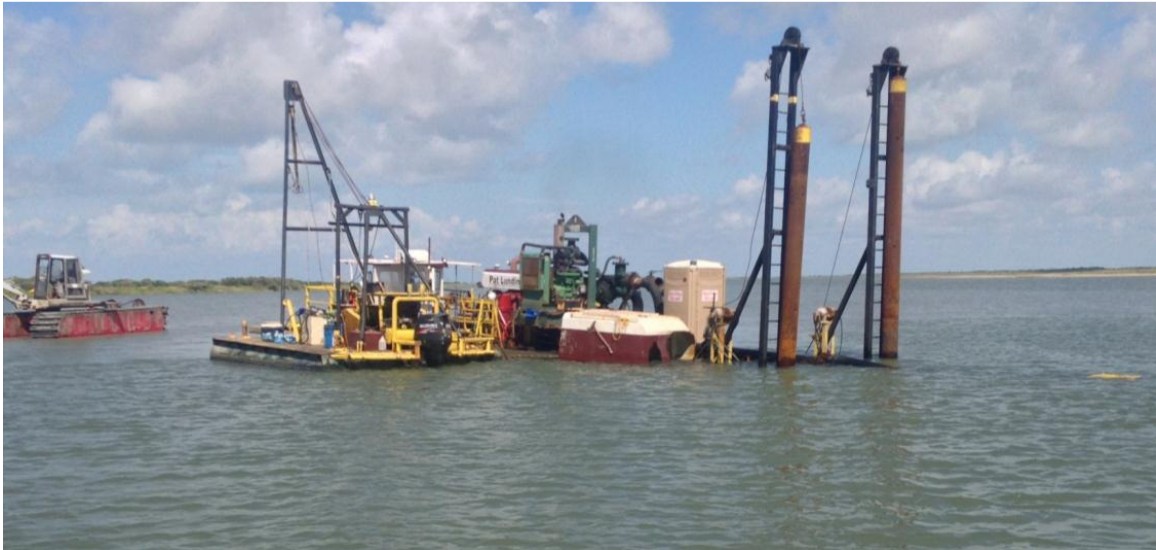
RLB continued dredging the western end of the Vinson Slough template this week. Total advance along the Vinson Slough design template is 6,700 feet since the project began. The hydraulic dredge working in Vinson Slough is shown in Figure 2.

**Figure 2. Dredge working in Vinson Slough.**

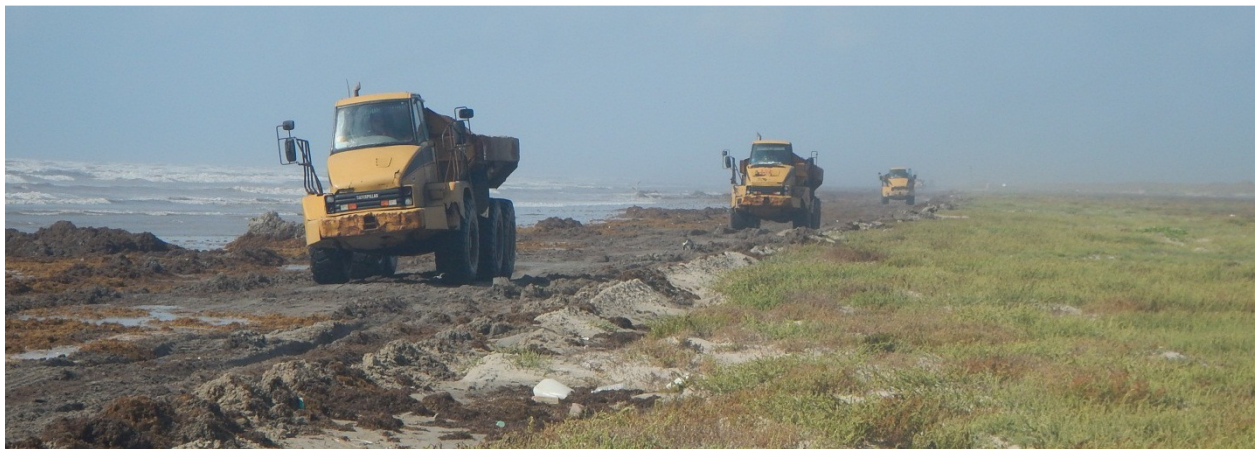
All material excavated from Cedar Bayou is transported by off-road trucks along the haul route and dumped into Placement Area 2. Material dredged from Vinson Slough is transported via pipeline to Placement Area 2. Figure 3 shows trucks returning from transporting material to Placement Area 2 on the specified haul route.

**Figure 3. Off-road trucks returning from transporting material to Placement Area 2**
